Test Report

Report No.: TMC220916103-S

Product Name: Mycro Headlamp

Test Type: Commission test

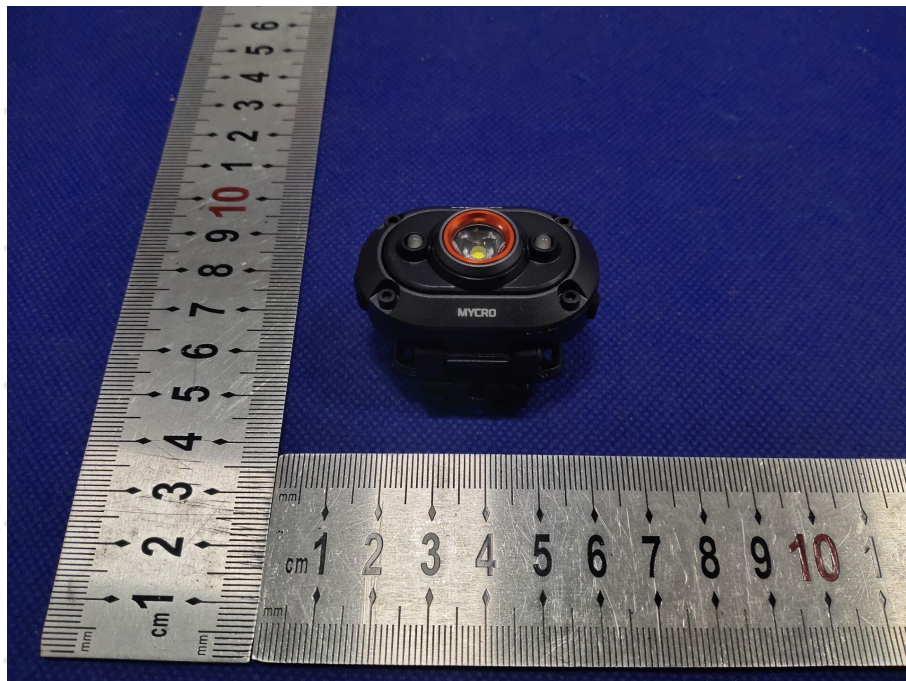
Photo 1 Before the test

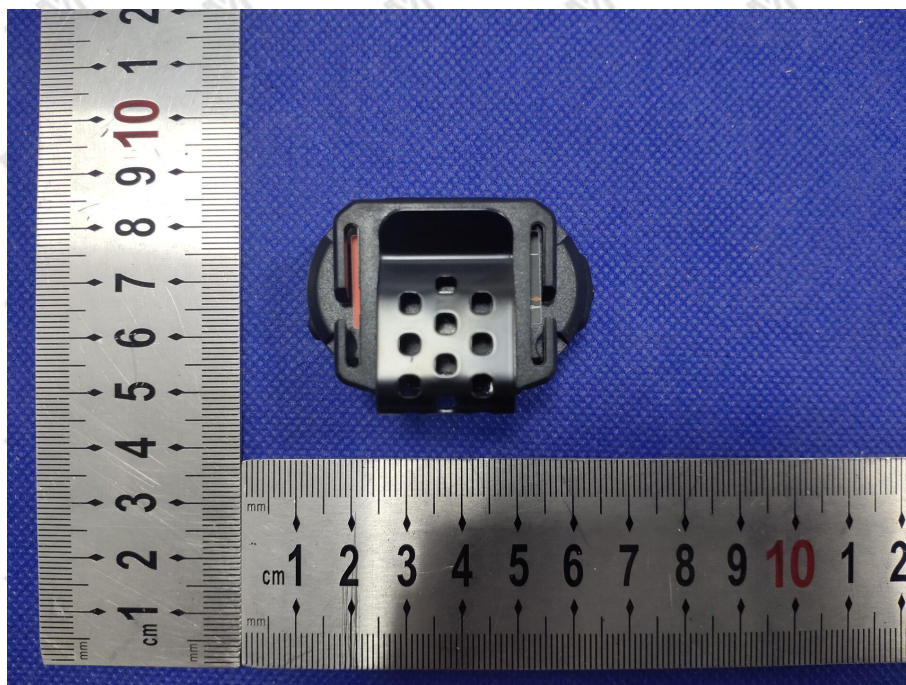
Photo 2 Before the test

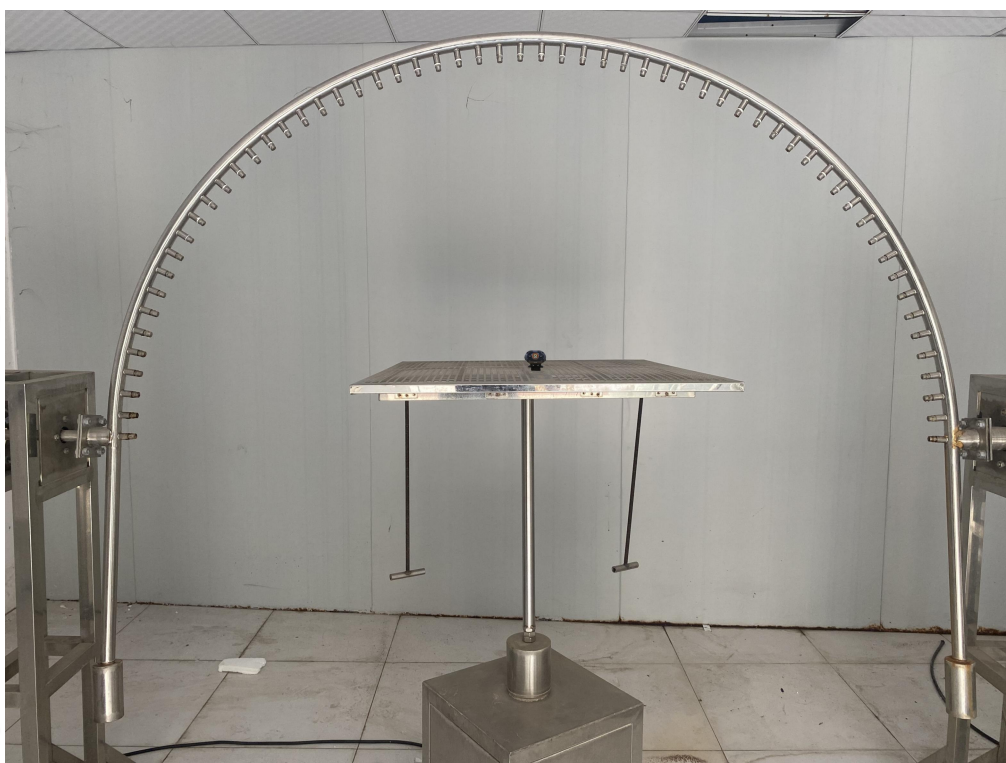
Photo IPX4

1.1 Test dept: 0,07 l/min \pm 5% per holes; 360°; rate of 1 r/min, After this 10 min period, the luminaire shall be switched off and allowed to cool naturally whilst the water spray is continued for a further 10 min

Test Item	Sample Name	Sample NO.	Test Result(s)	Conclusion
IPX4	NEB-HLP-0011-G	220916103	No water ingress	Pass
